Hydrogeologic Appraisal of the Cayuga County Ground-Water Contamination Superfund Site near Auburn, NY

David A. Eckhardt, USGS, Ithaca, NY

**U. S Department of the Interior
U. S. Geological Survey**

**In cooperation with
U. S. Environmental Protection Agency**

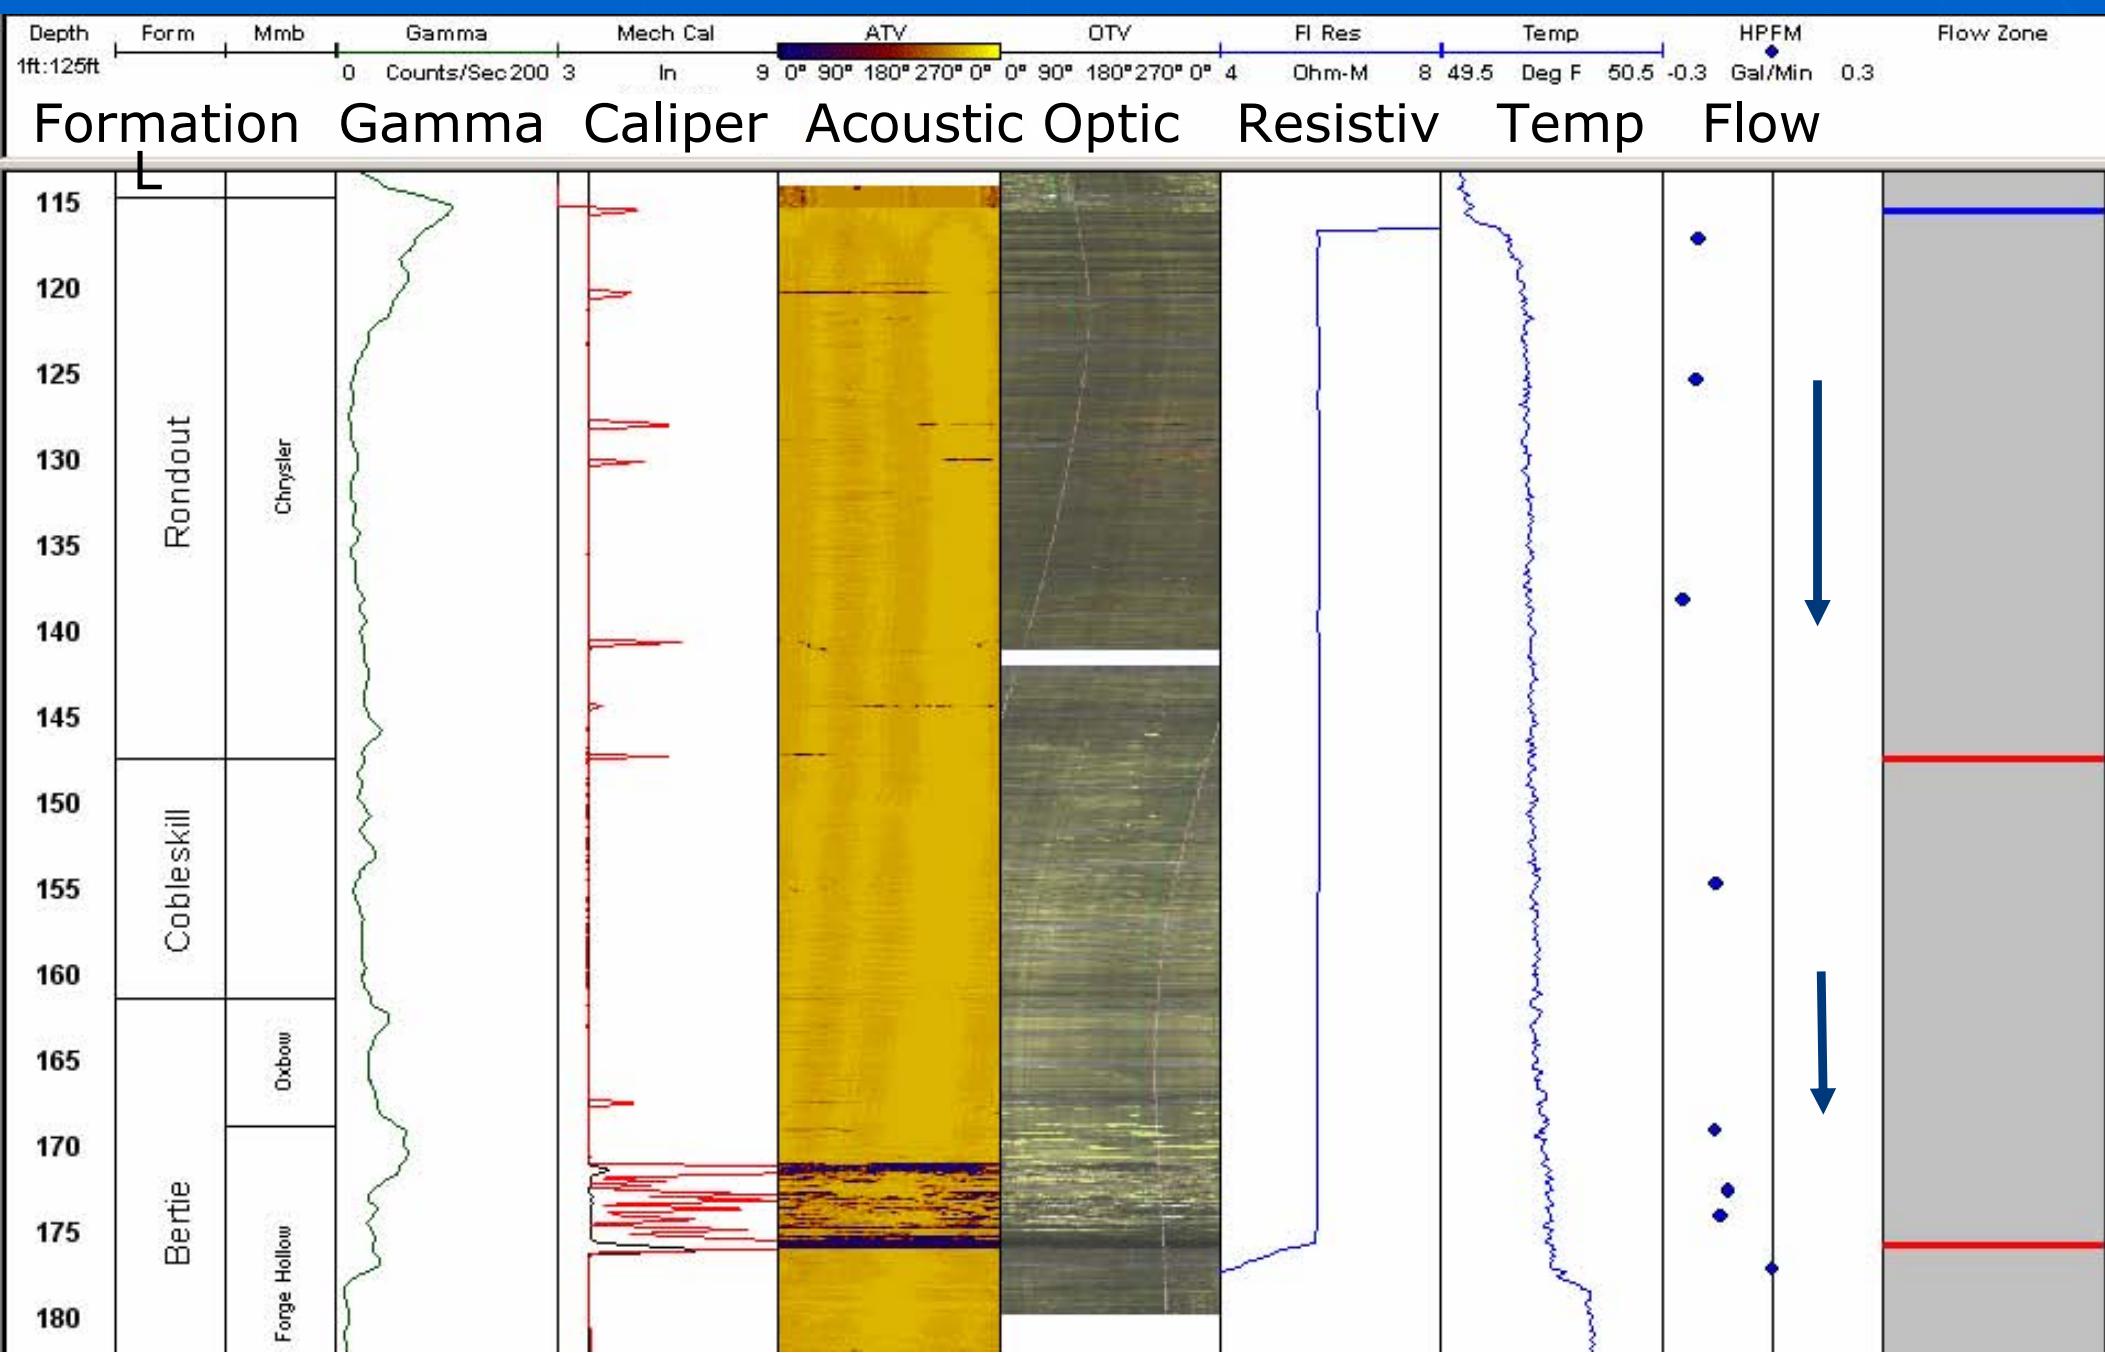
EPA-5

Geophysical, Stratigraphic, and Flow-Zone Logs

Formation Gamma Caliper ATV-1 ATV-2 Resistiv Temp Flow

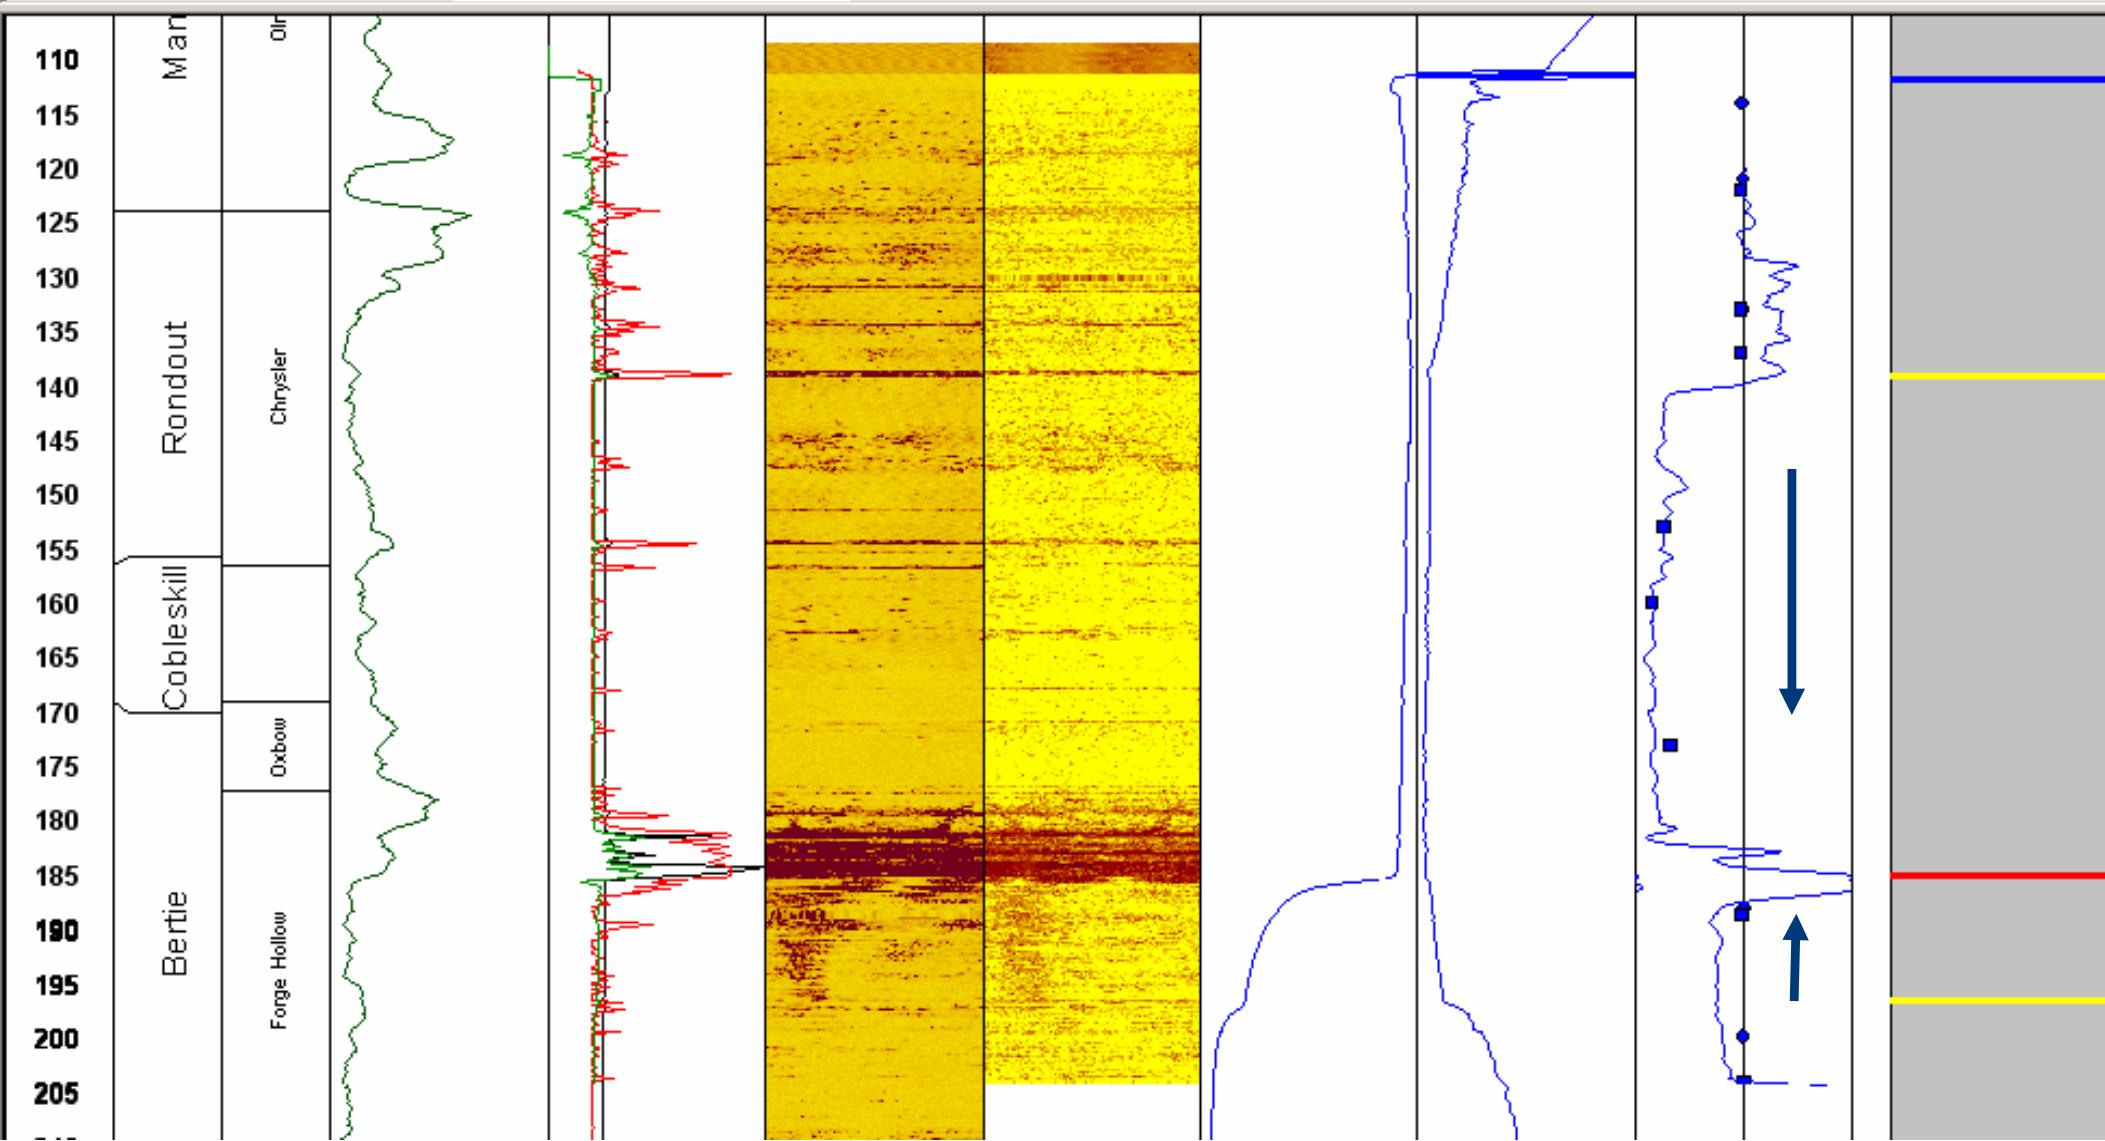
EPA-5

Geophysical, Stratigraphic, and Flow-Zone Logs

Form. Gamma Caliper ATV Amb-Flow Pump-Flow Resistivity

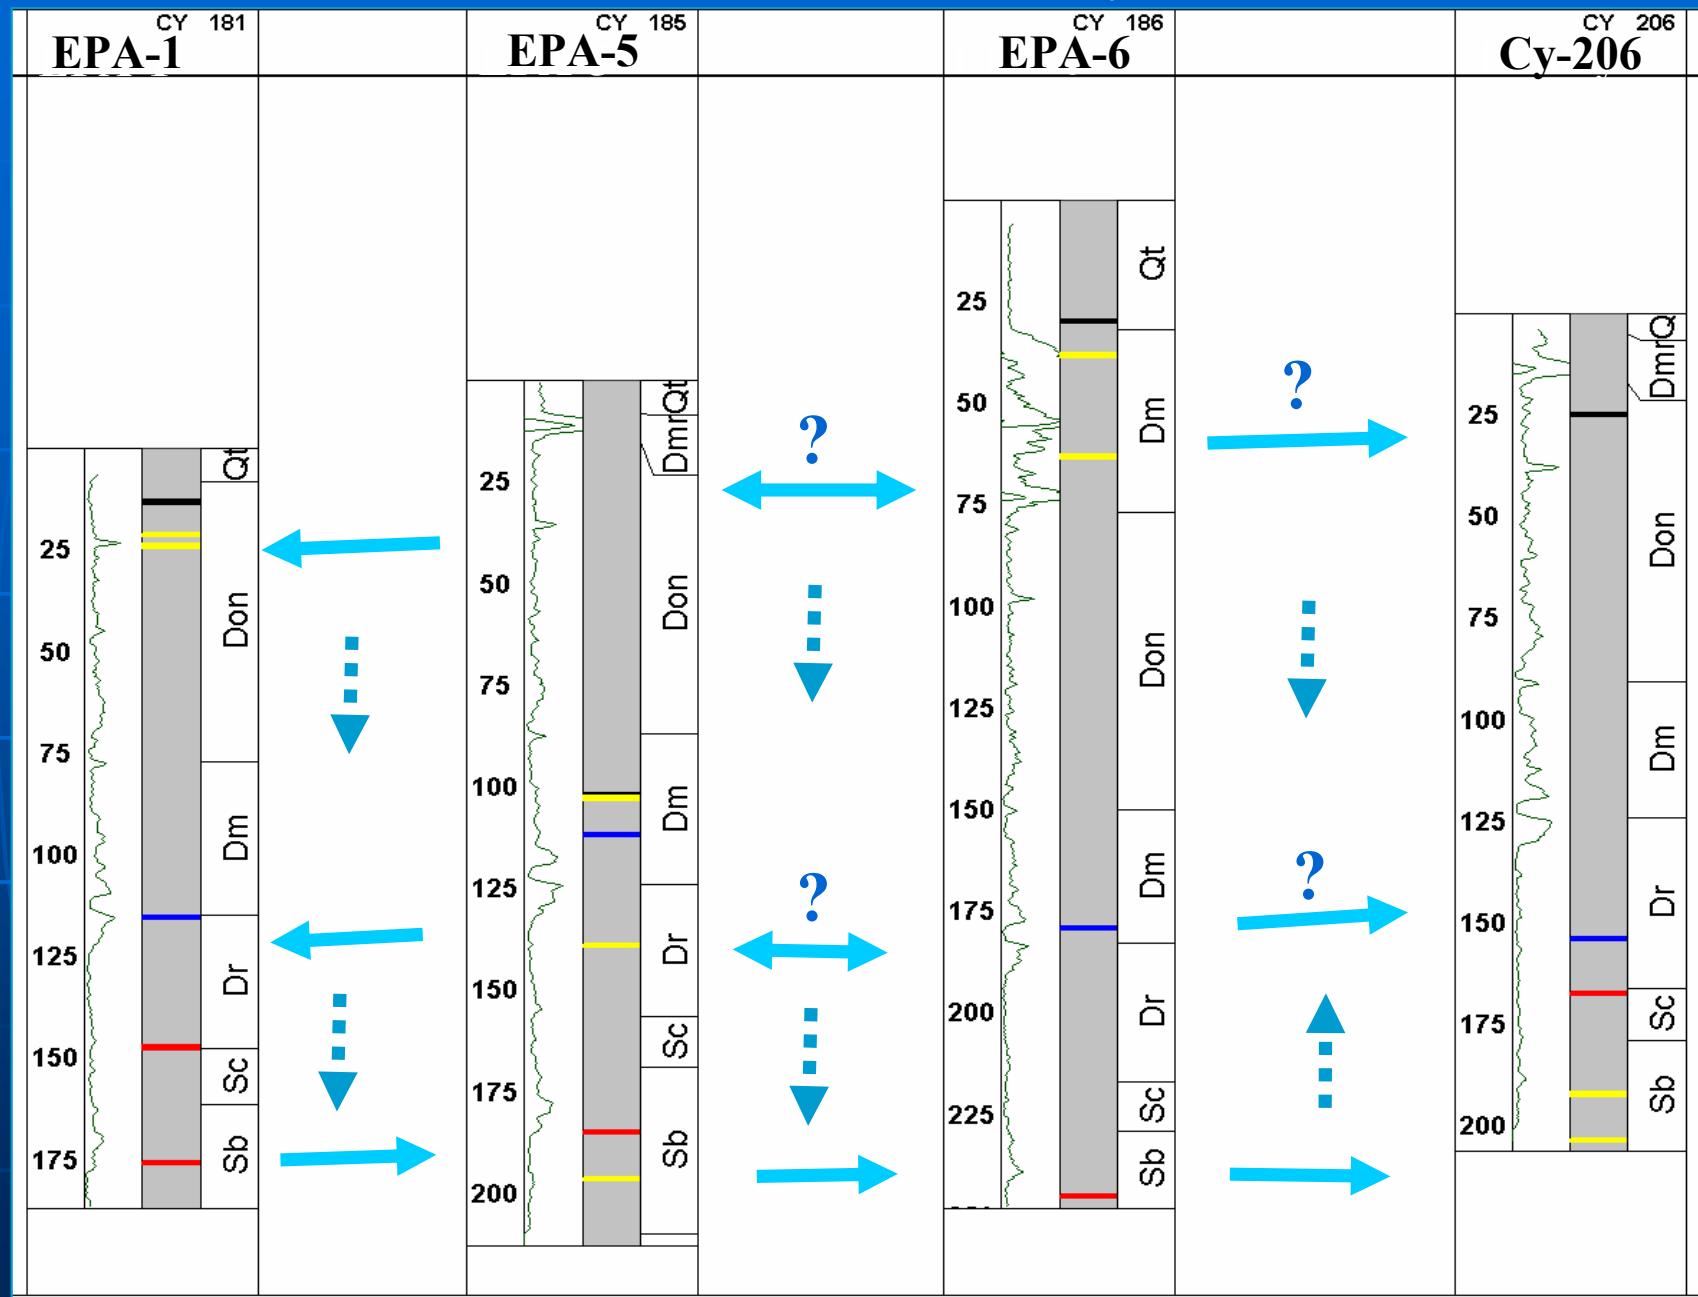
NORTH

Elmhurst Dr. -- Pinckney Rd.

SOUTH

Horizontal flow

Downward gradient

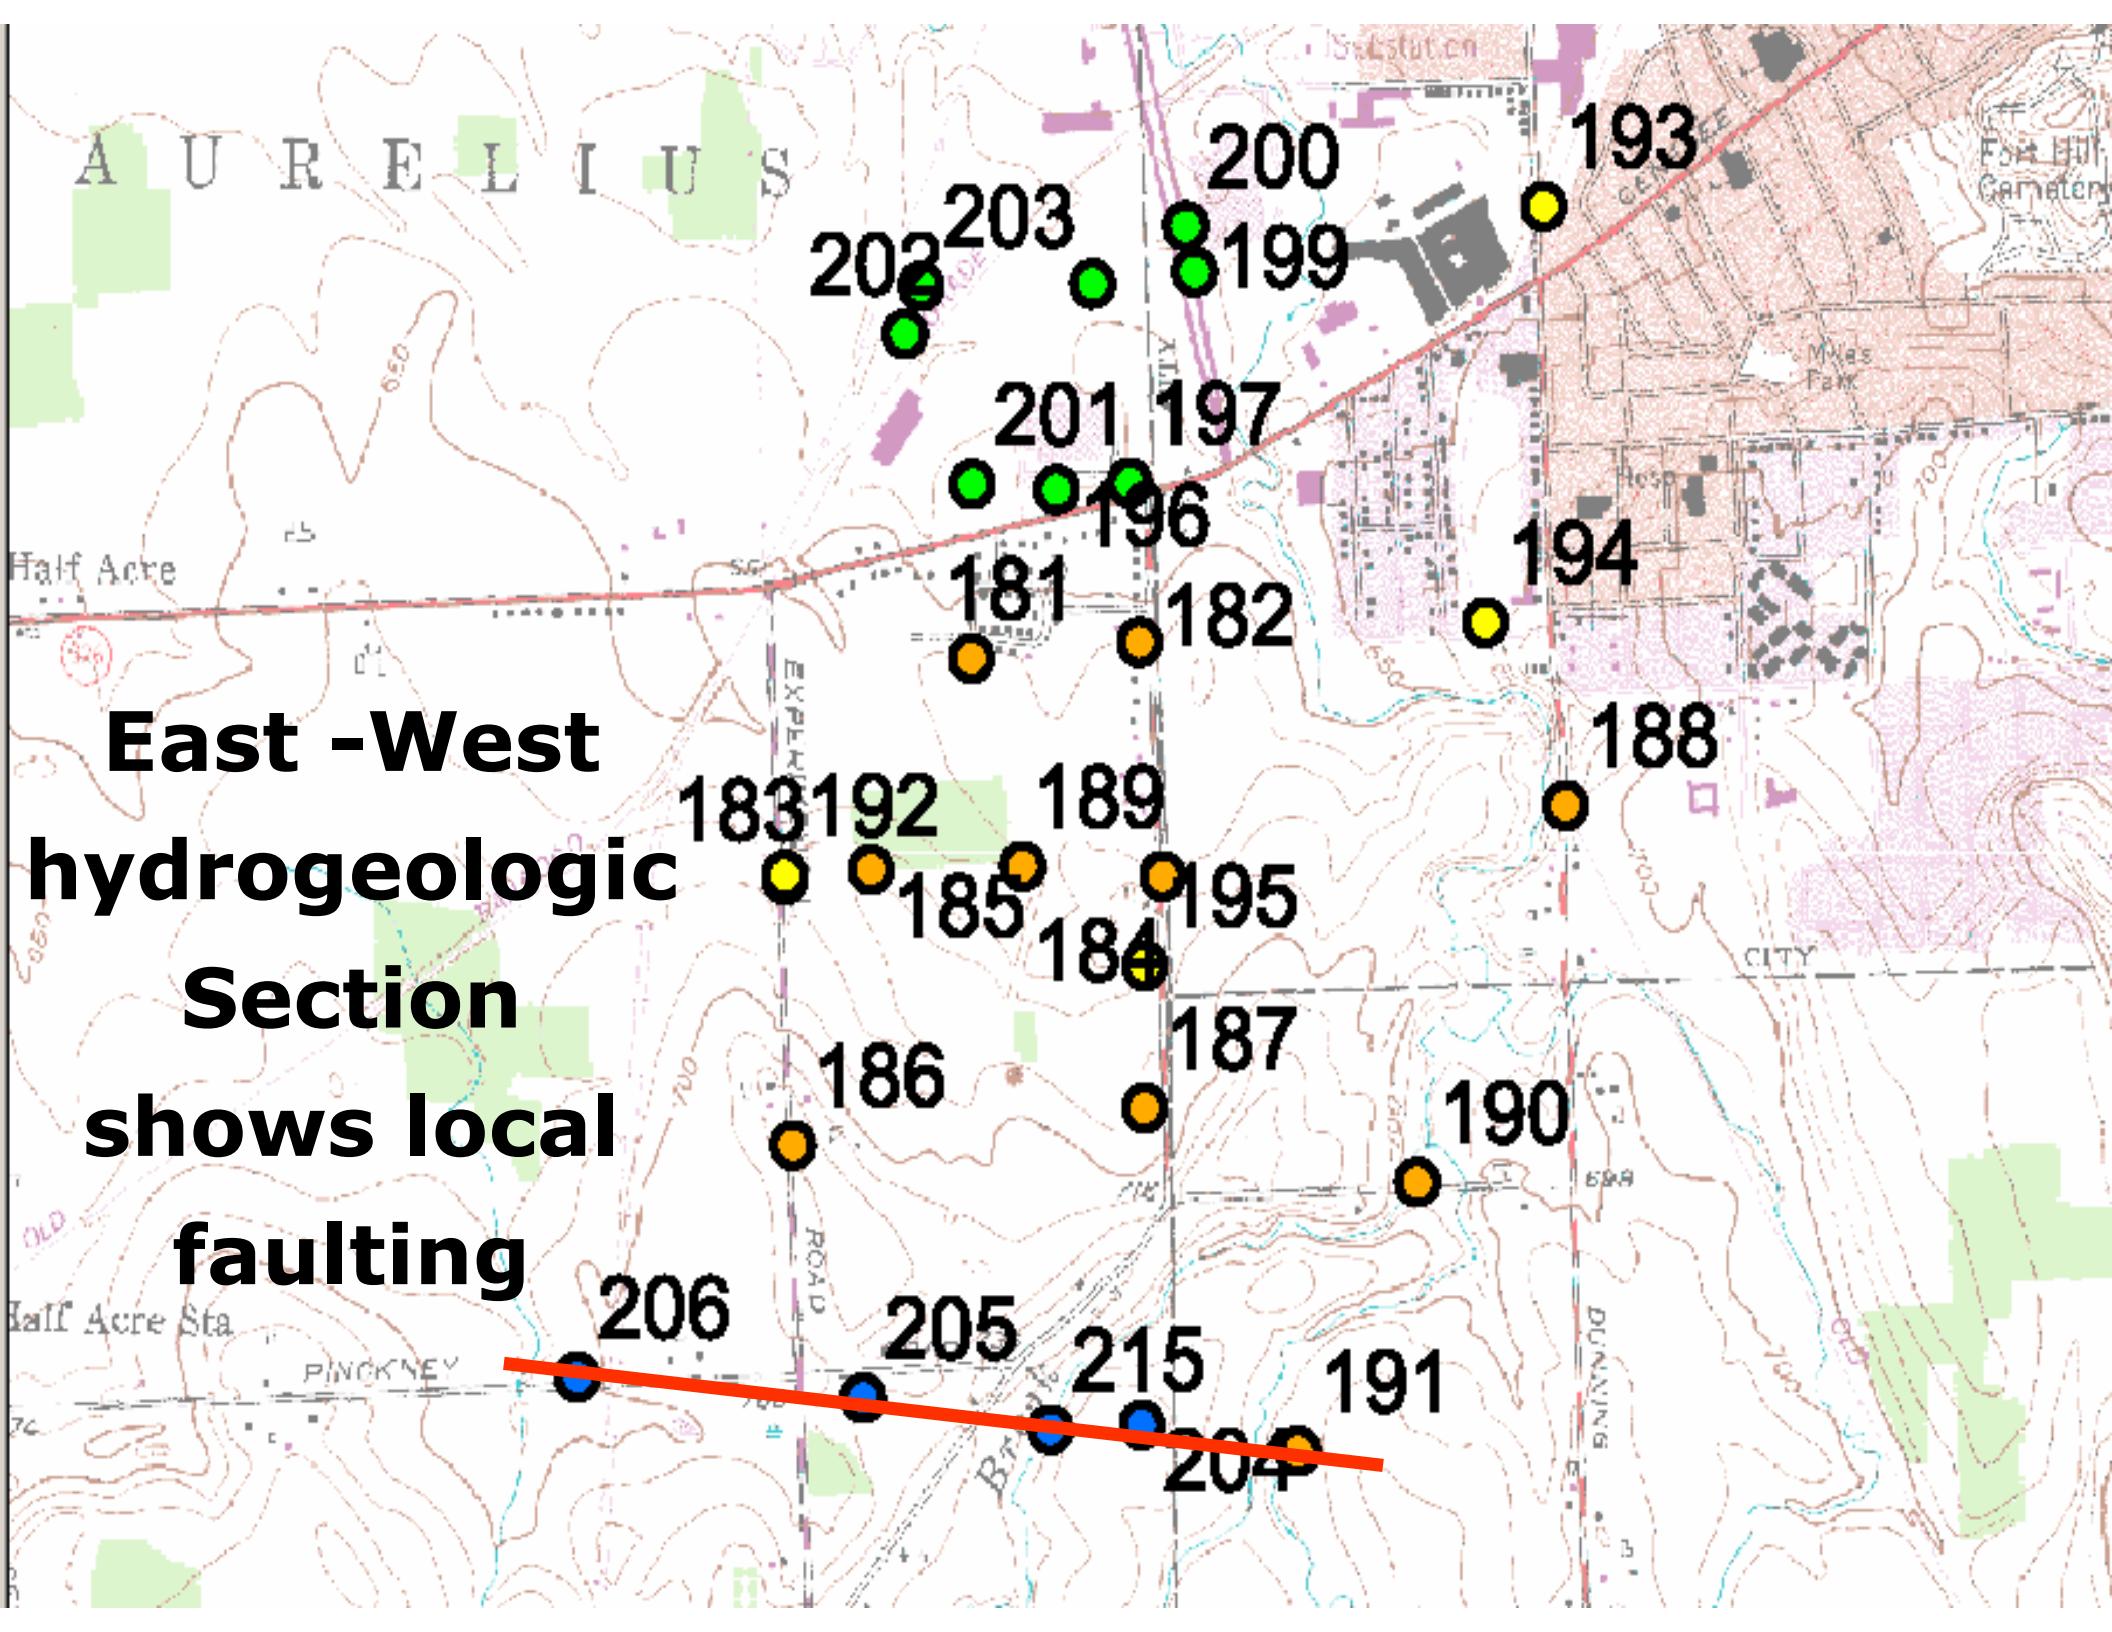
**East -West
hydrogeologic
Section
shows local
faulting**

WEST

Pinckney Rd. – Overbrook Dr.

EAST

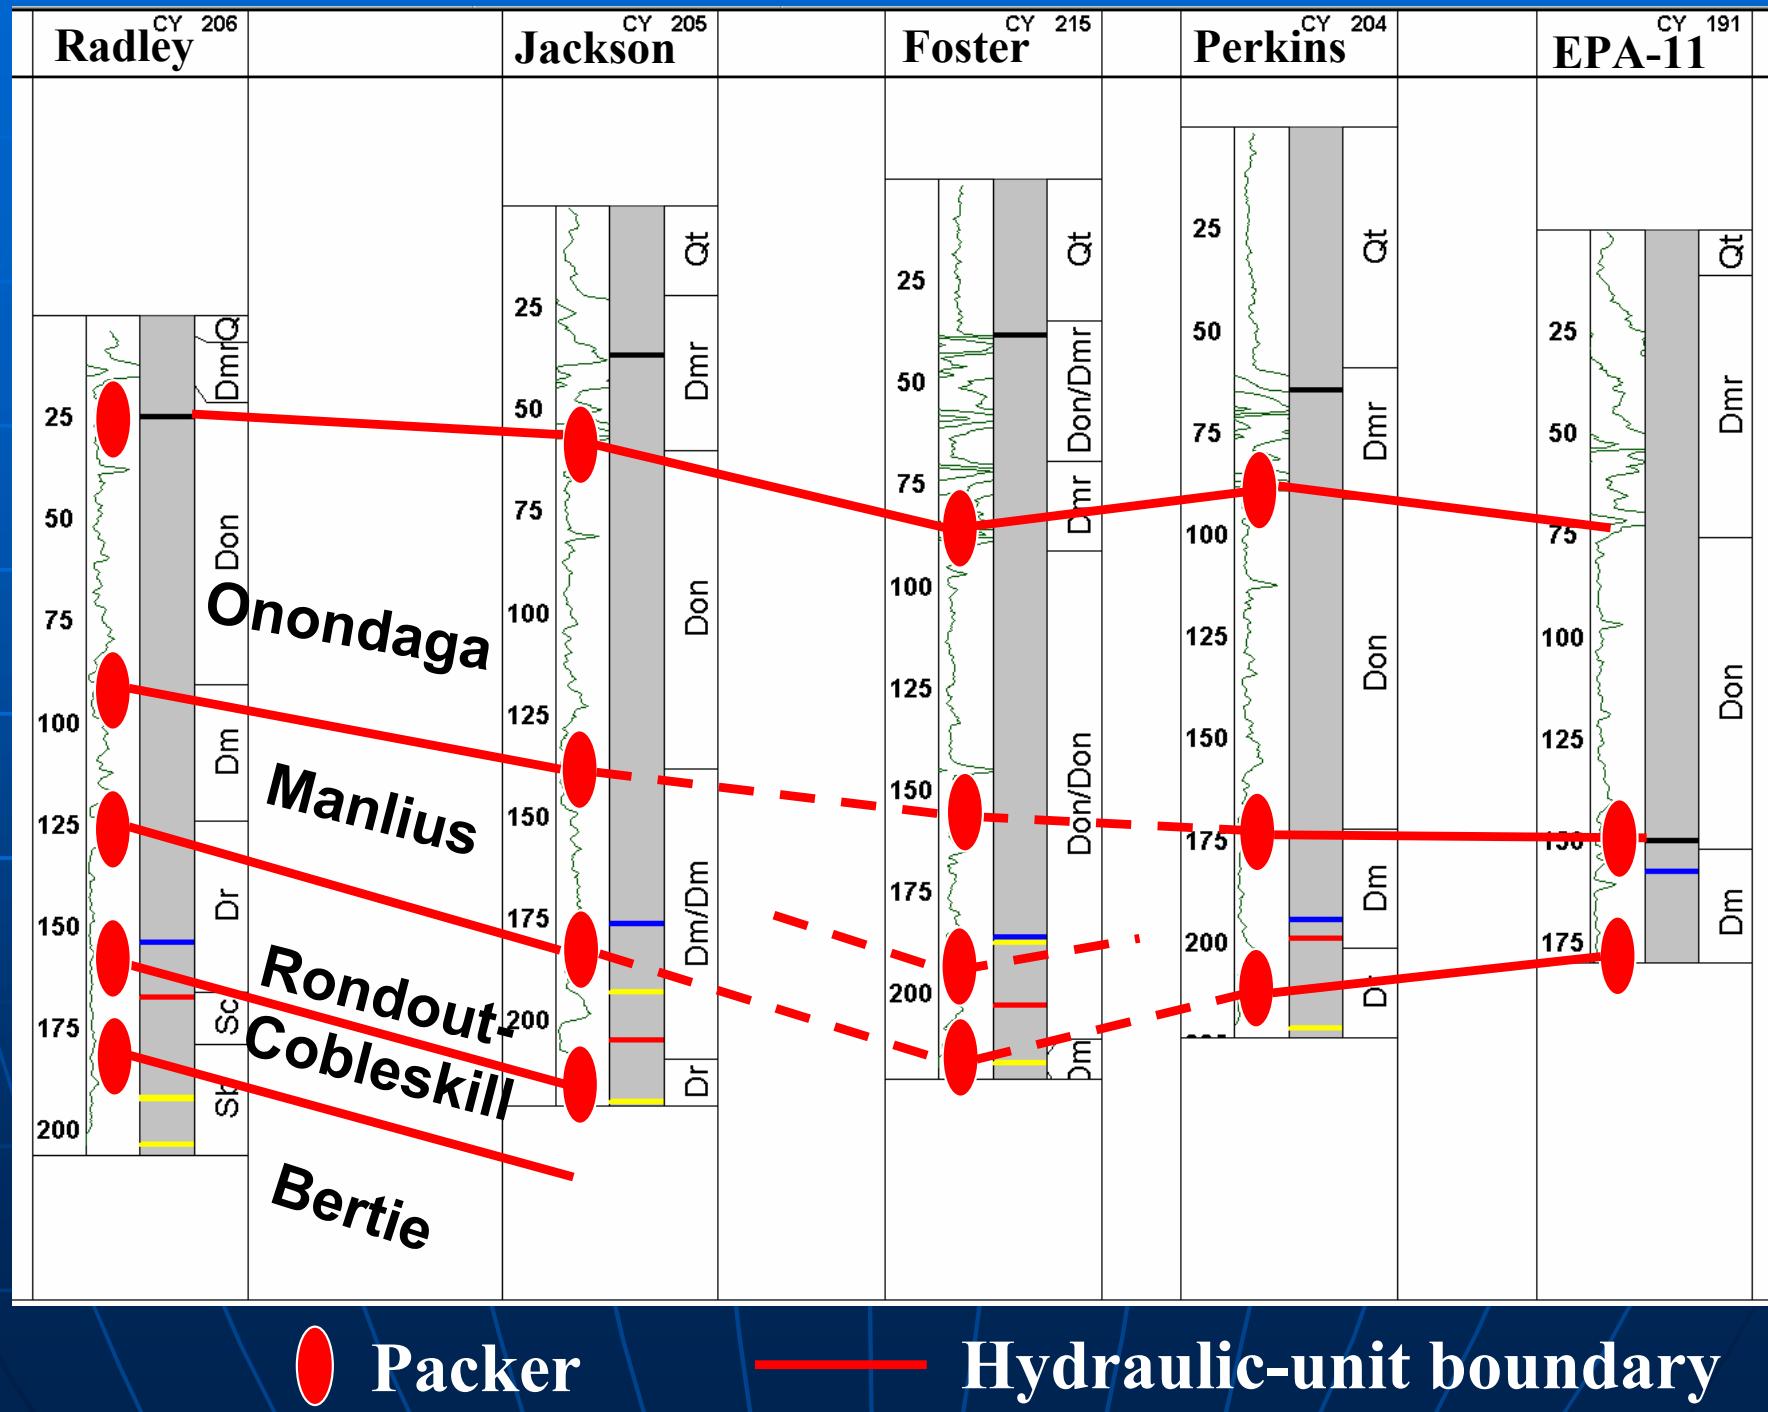
WEST

Pinckney Rd. – Overbrook Dr.

EAST

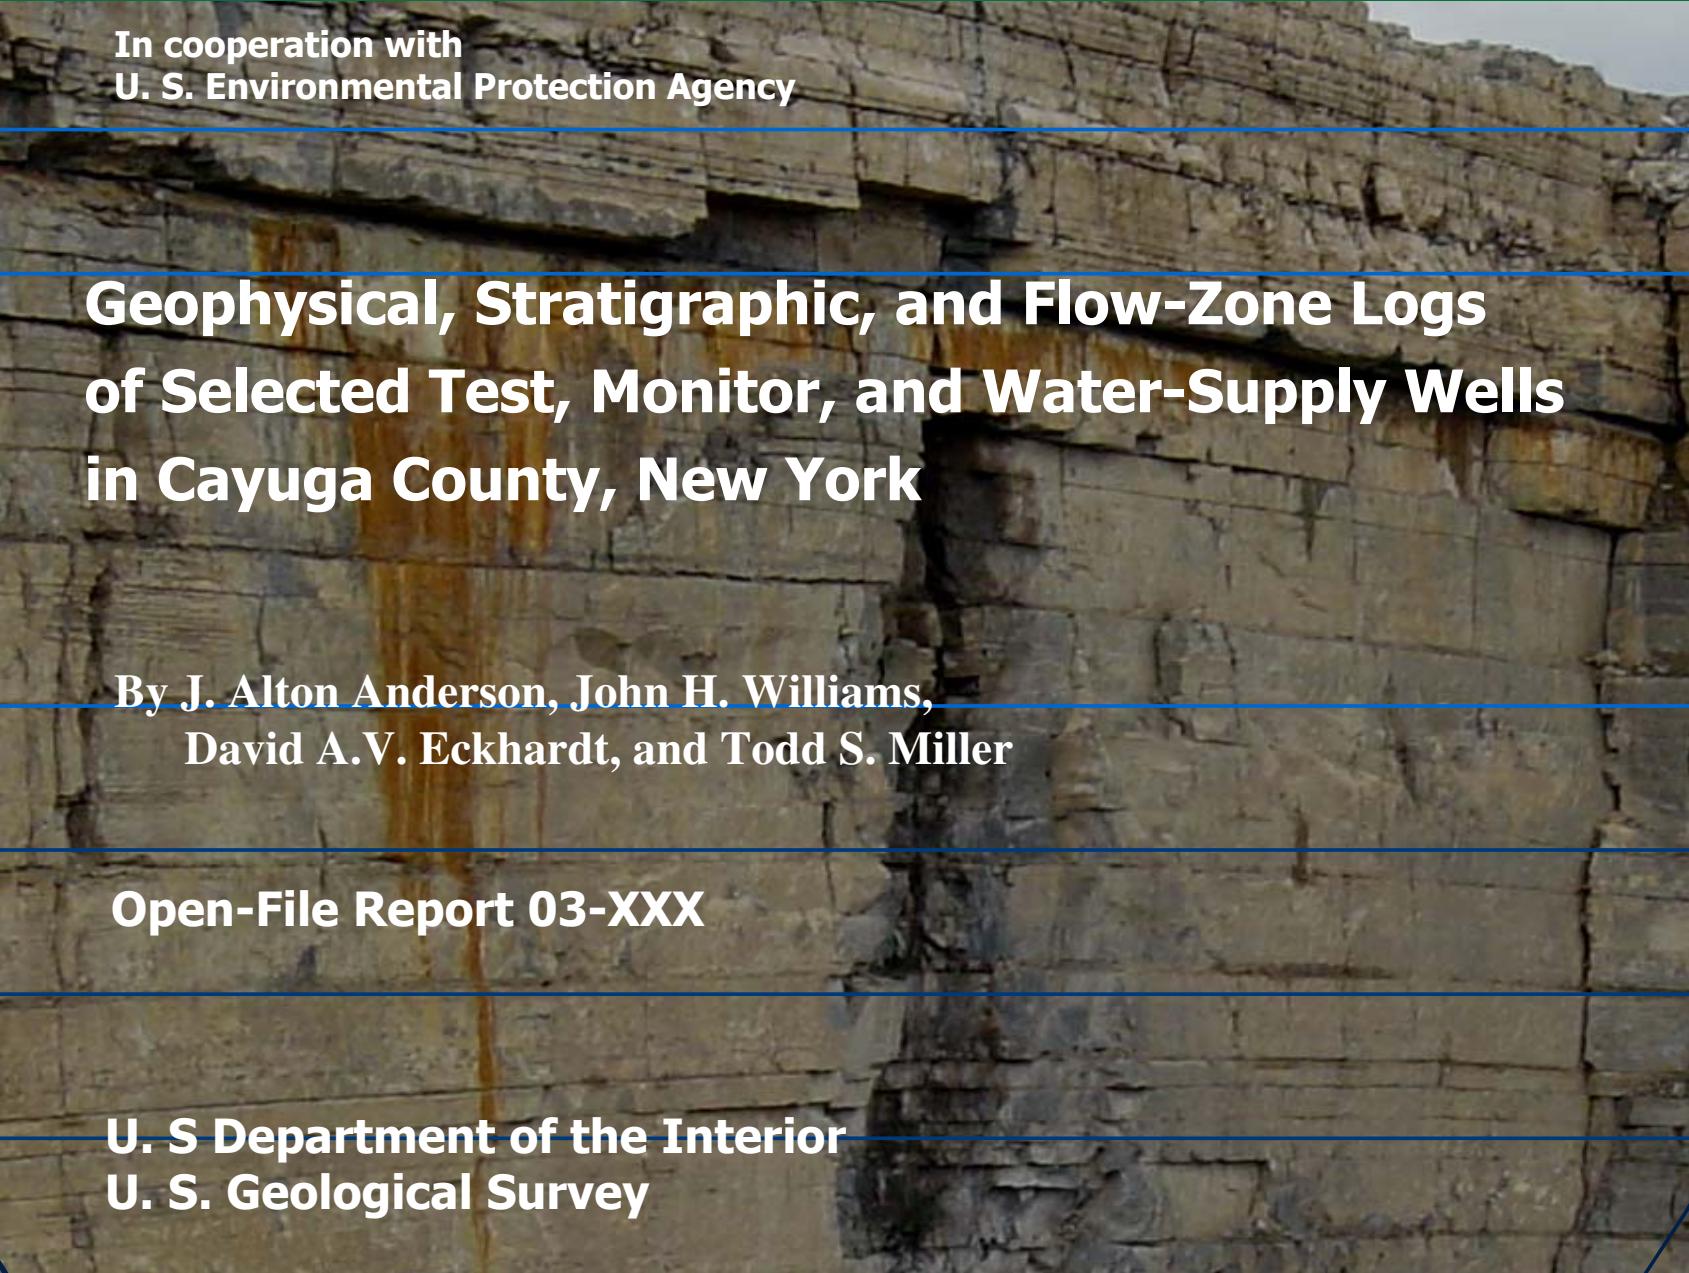
A large, rectangular photograph of a geological outcrop occupies the central portion of the page. The image shows a vertical rock face with prominent, thin, horizontal sedimentary layers or strata. The rock has a weathered, brownish-tan appearance with darker, possibly organic-rich, streaks running vertically through it. The lighting highlights the texture and thickness of the individual layers.
